Case History

Coalescer Assembly Module

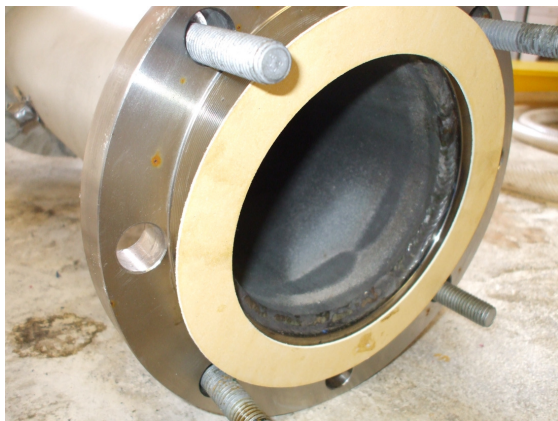
Siemens had a Coalescer Assembly Module (oil separator) returned to them, with the 6" diameter internal pipe work in a rusty condition. The overall affected length was approximately 5m.

The reason for this, was that the pipes hadn't been sealed correctly on the module. Siemens approached HITEK-nology Solutions Ltd (HSL) to provide a solution that would result in the tubes being reclaimed and protected until reassembly and subsequent use. This task also needed to be completed within three days including collection and delivery between Siemens and HSL.

The internal volume of the pipes was soaked in VpCI 422 to de-rust them. They were then soaked in 10% VpCI 416 mix to clean / de-grease them. The ends were then removed to allow any waste and debris etc. to be removed, and the internal surface to be inspected and dried. The internal volume of the pipes was treated with VpCI 322, to protect them from future corrosion prior to installation and use.
