Case History

ZF casings

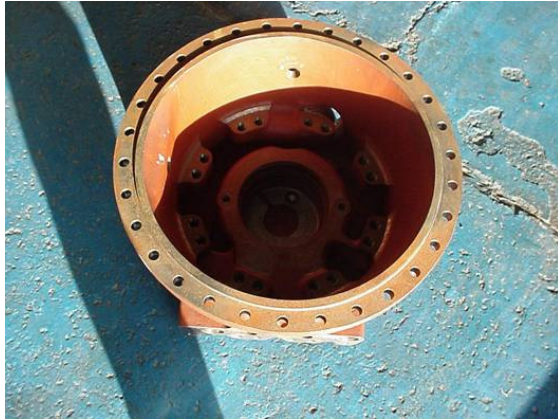
ZF casings are a cast casing that houses the cogs and motors for driving the lorry mounted cement mixers.

Bosch Rexroth had been storing these casings in an environment that had caused the casings to rust. They were in the process of scrapping the casings when they decided to approach HITEK-nology Solutions Ltd to provide a solution.

The casings were soaked in VpCI 422 to remove the rust. The casings were then washed down with VpCI 415 and dipped in 418LM to clean / degrease them. The casings were then misted with VpCI 377 to give them a protective coating until fitment. The result was that Bosch Rexroth were able to use the casings at a fraction of the cost to buy new.
