Case History

UOP Gas Tubes

Customer
UOP

Location
EXTERRAN Ltd, Walsall

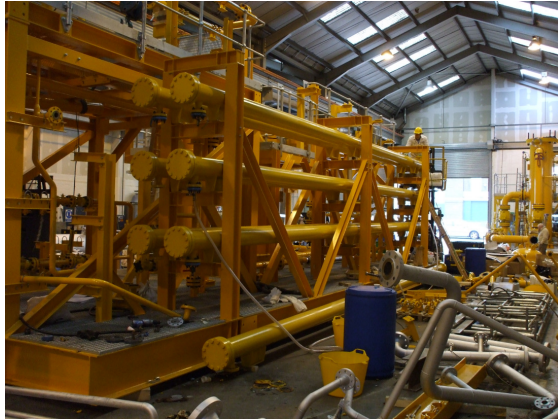
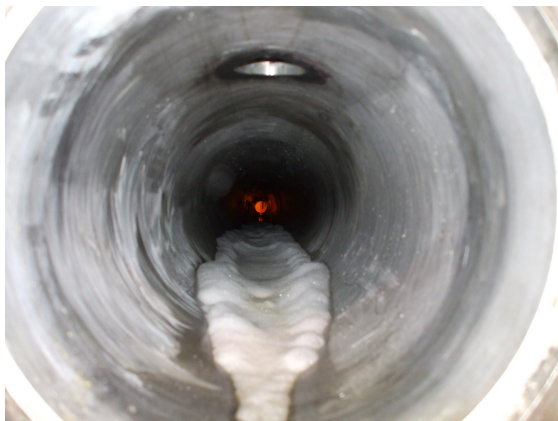
UOP manufacture gas tubes which are used world wide. Seven of these tubes had arrived in the UK from USA in a corroded state and were subsequently rejected by EXTERRAN.

The internal volume of the tubes was soaked in VpCI 422 to de-rust them. They were then soaked in 10% VpCI 416 mix to clean / de-grease them. The ends were then removed to allow any waste and debris etc. to be removed, and the internal surface to be inspected and measured. The ends were then placed back on, and the internal volume of the tubes were treated with 20% VpCI 377 mix, to protect them from future corrosion prior to installation and use.

Upon inspection by UOP's inspector it was decided that two of the seven tubes could not be used, and would require re-honing. This was due to the amount of corrosion that had already happened; resulting in the internal surface having variations of more than 33 microns (only a variation of up to 33 microns was acceptable for gas to flow correctly). HSL had however managed to make five of the tubes re-usable, resulting in a saving of millions of US Dollars.
