Case History

Warship Blister Tanks

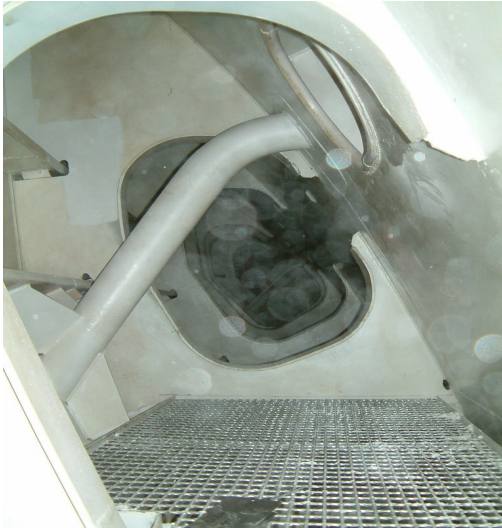
HSL were requested to retreat the Blister Tanks again in June 2008, on the left is a picture of the sacrificial plates placed in the Tanks in 2006, as can be seen two years protection was achieved.

VpCI 609 is fogged into the internal volume of the voids resulting in a low cost two years anti-corrosion protection.
